Hong Kong International Airport Investigation of Airport Runways

Description of Work

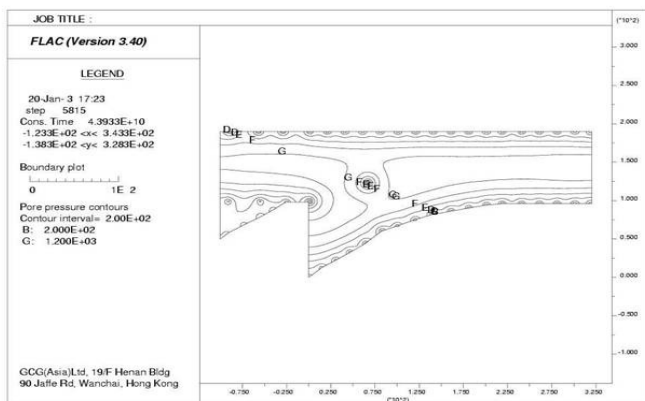
**FLAC modelling of air pressure build-up
on the runway and taxiway**

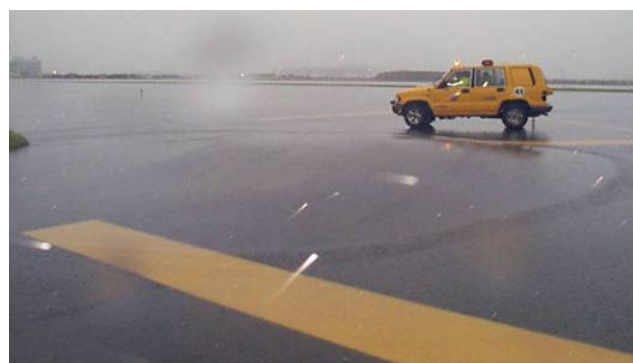
The new Hong Kong International Airport opened on 8 July 98. Following airport opening the asphalt surfacing at certain locations on the shoulders of the northern runway and taxiways was found to heave during extreme wet weather. The heave took the form of domes with a diameter of 2m to 10 m and a height of 50mm to 500 mm. The domes typically subsided within an hour but the asphalt surfacing was often damaged within the footprint of the dome.

GCG (Asia) Ltd was commissioned by the Airport Authority to identify the source of the heaving problem and to design remedial measures to prevent the heaving. The investigation work included extensive monitoring of the air pressure beneath the asphalt and measurement of the air permeability of the runway pavement materials. The air pressure monitoring equipment and laboratory permeability equipment and test methods were designed by GCG (Asia) Ltd. The investigation work identified that the problem was caused by the rising tidal water level beneath the runway displacing air from the voids in the fill. The reduction in the permeability of the pavement materials during wet weather due to surface tension effects effectively trapped the air, causing heave of the surfacing.

Asphalt dome on taxiway

GCG (Asia) Ltd. carried out detailed numerical modelling of the air flow within the reclamation and developed the design for a system of vertical vent pipes adjacent to the runway to assist in dissipating the air pressure build up. The results of the numerical modelling have been calibrated against the pressure monitoring data. The air vents have now been installed and form the permanent solution to the runway/taxiway heaving problem at the Hong Kong International Airport.

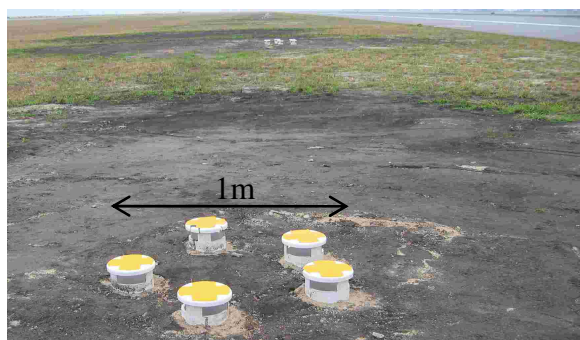
Air vent
