Expert Advice Fill Slope Collapse in Hong Kong

Description of Work

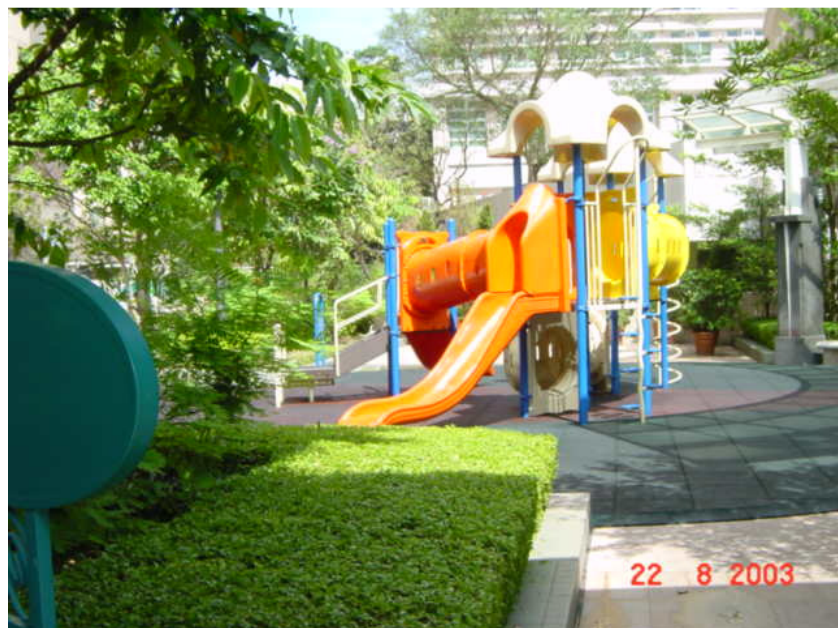
Completed Playground near to repaired slope
